HOWARD 810 c.c. TWIN CYLINDER ENGINE—RE-CONDITIONING

APRIL 1963

HOWARD—810cc. TWIN CYLINDER ENGINE

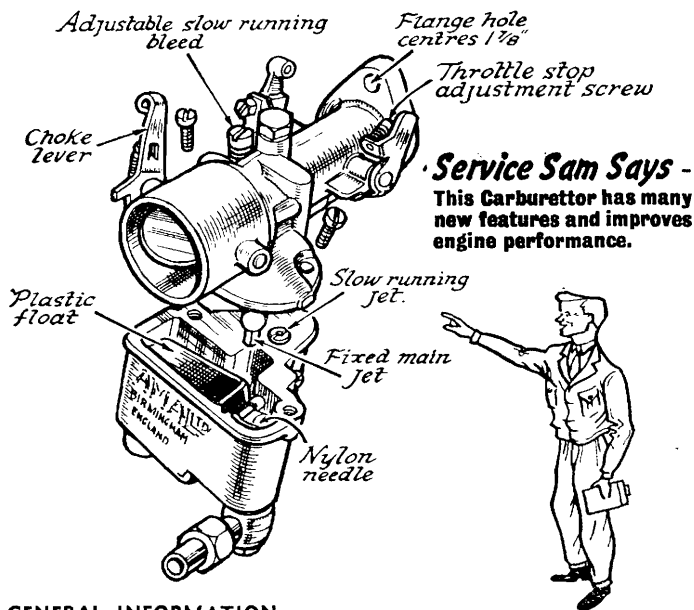
As from Engine No. 2611166 a new type Carburettor—Amal type 397/1 will be fitted to the 810cc. Twin Engine replacing the present Amal 348/10. This will also include fitting a new fuel pipe (Part No. 27047) which replaces (Part No. 26895) fuel pipe.

Service Sam Says -
This Carburettor has many new features and improves engine performance.

That when fitting type 397/1 to an Induction Pipe having 2" centre studs in the induction manifold, the carburettor flange holes must be elongated to suit. Make certain you have an air-tight joint.

There is only one variable adjustment, i.e.: the slow running adjustment effected by the Air Bleed Screw situated between throttle control and choke lever. To set the carburettor, screw down air bleed screw, i.e.: bottoms on seating (do not force or needle seat will be damaged). Unscrew $\frac{1}{2}$ -turn, start engine, allow to warm up and settle the adjustment by screwing in or out until desired slow running is achieved.
